ARBORIST REPORT

STATE BRIDGE RD SITE
State Bride Road
CITY OF JOHNS CREEK, GEORGIA

July 5, 2023

RE: Level 2 Arborist Inspection
State Bridge Rd – City of Johns Creek Ga Parcel: 11 094002990166

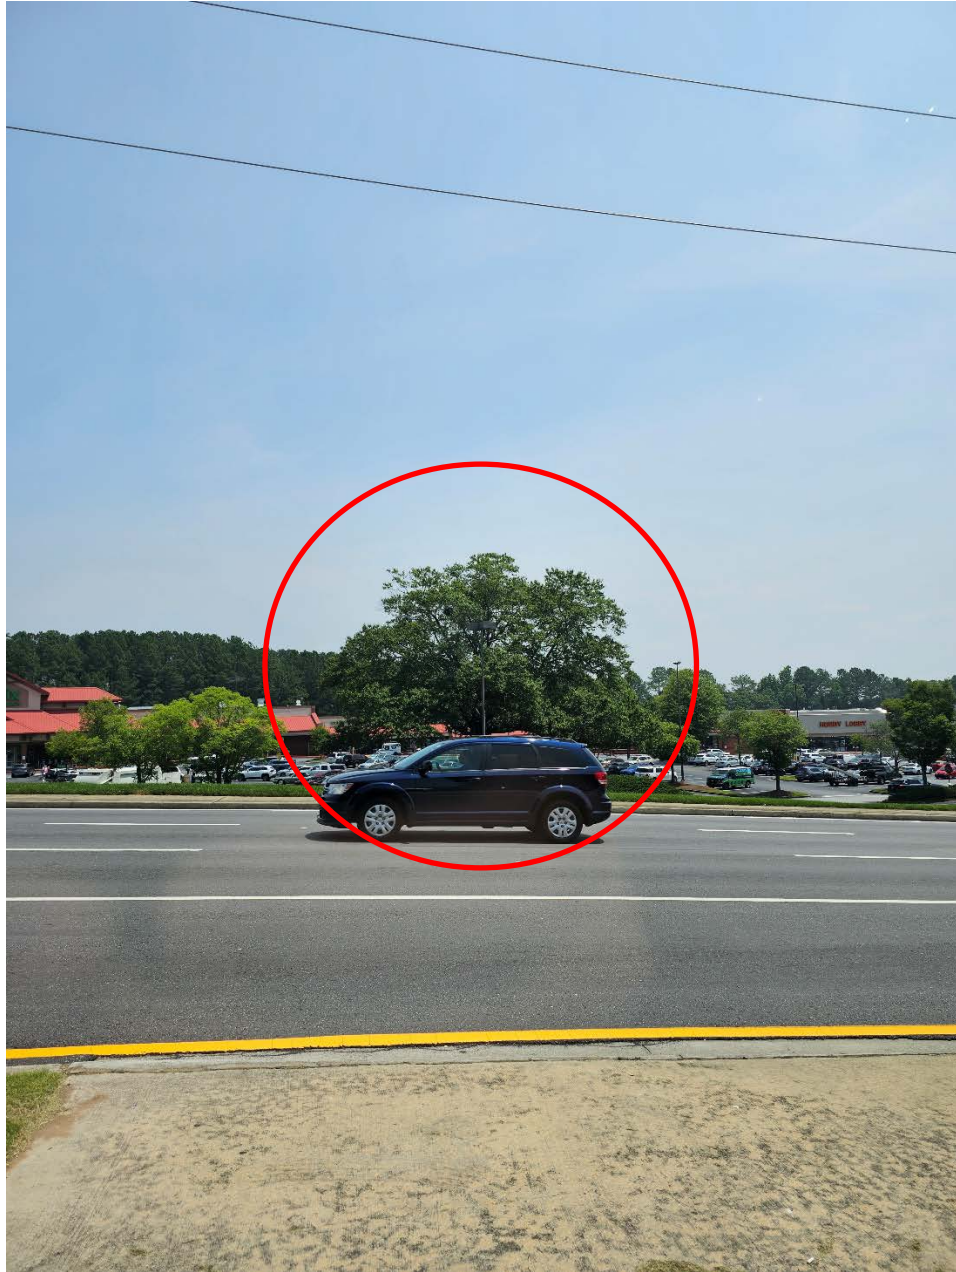
Figure 1. Tree located towards front of development

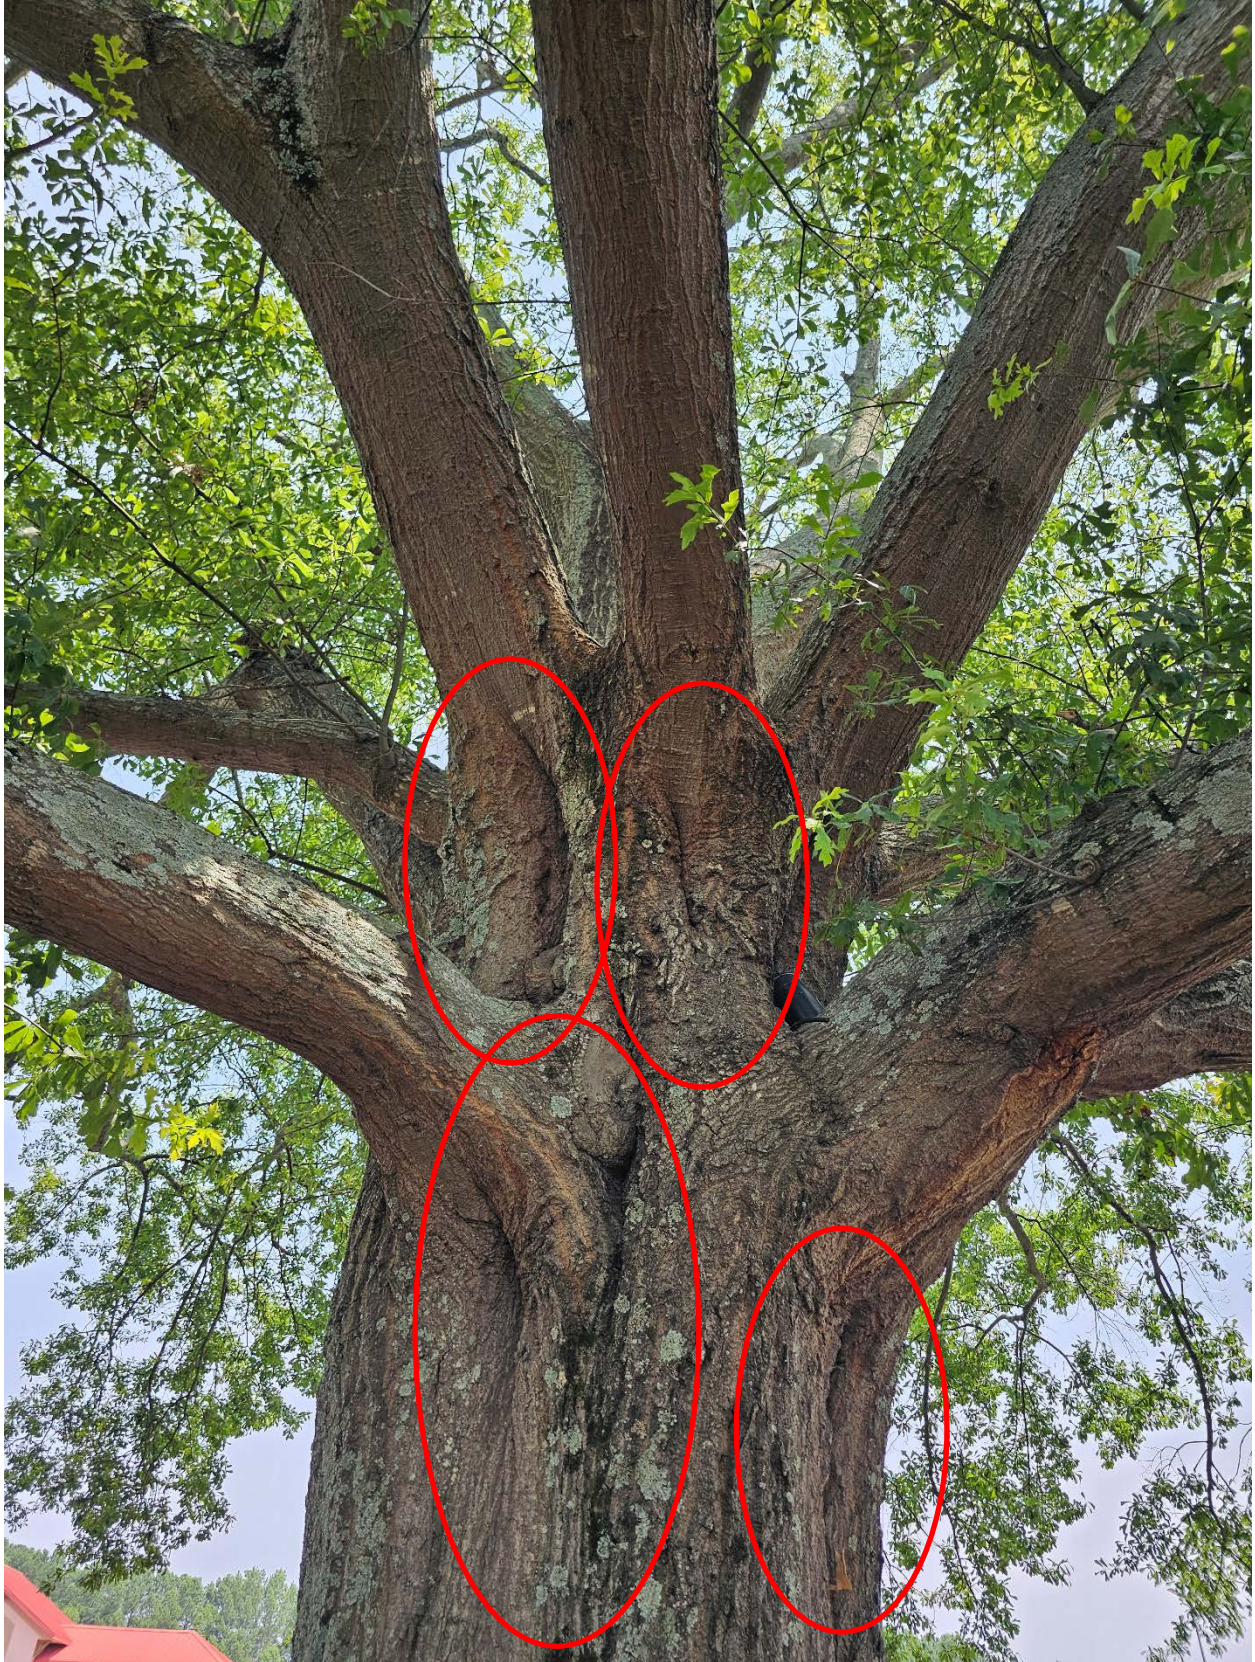
Figure 2. Multiple areas of bark inclusion

Due to the severity of the structural deficiencies of these trees, there is no amount of engineering design improvements that can be made to assist in the longevity of the trees. It would be recommended to remove the tree to reduce the risk to the public and replace with a species of tree that would be more appropriate.

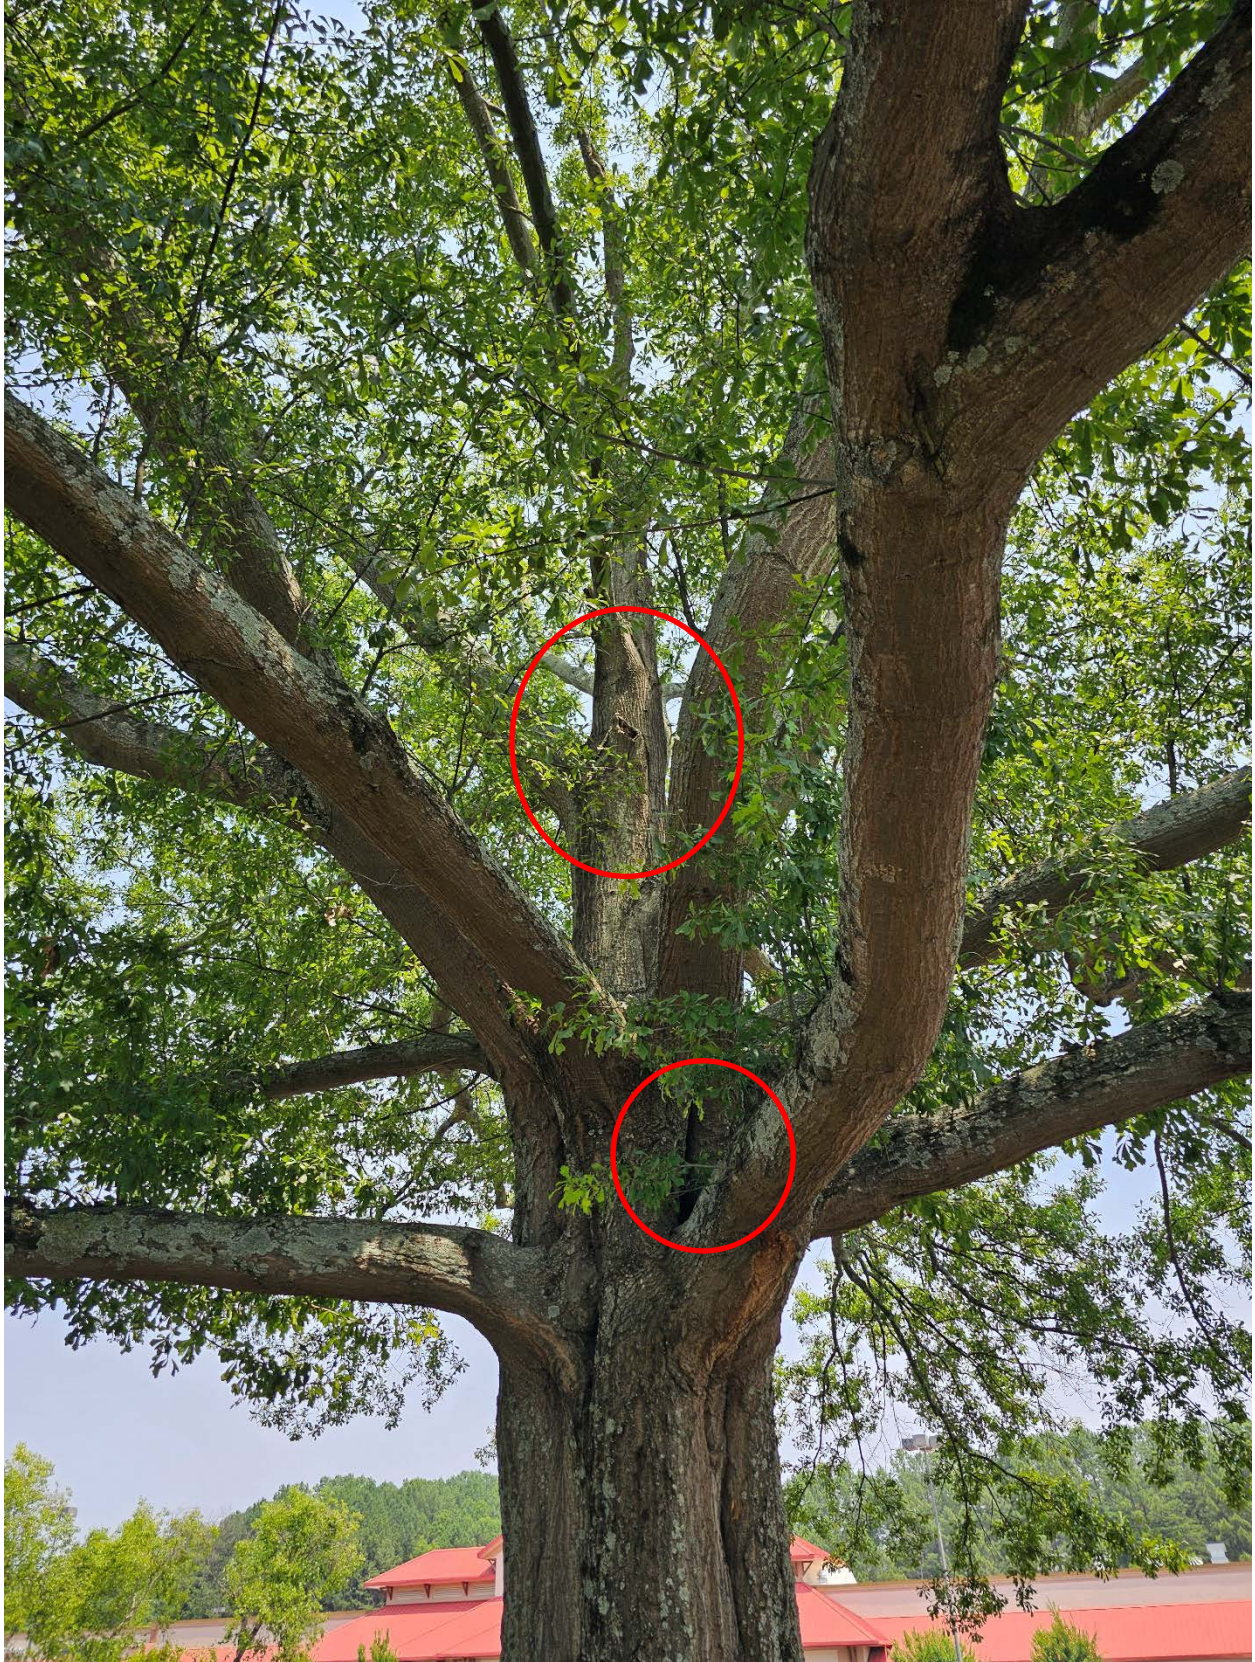
Figure 3. Decay in tree trunk

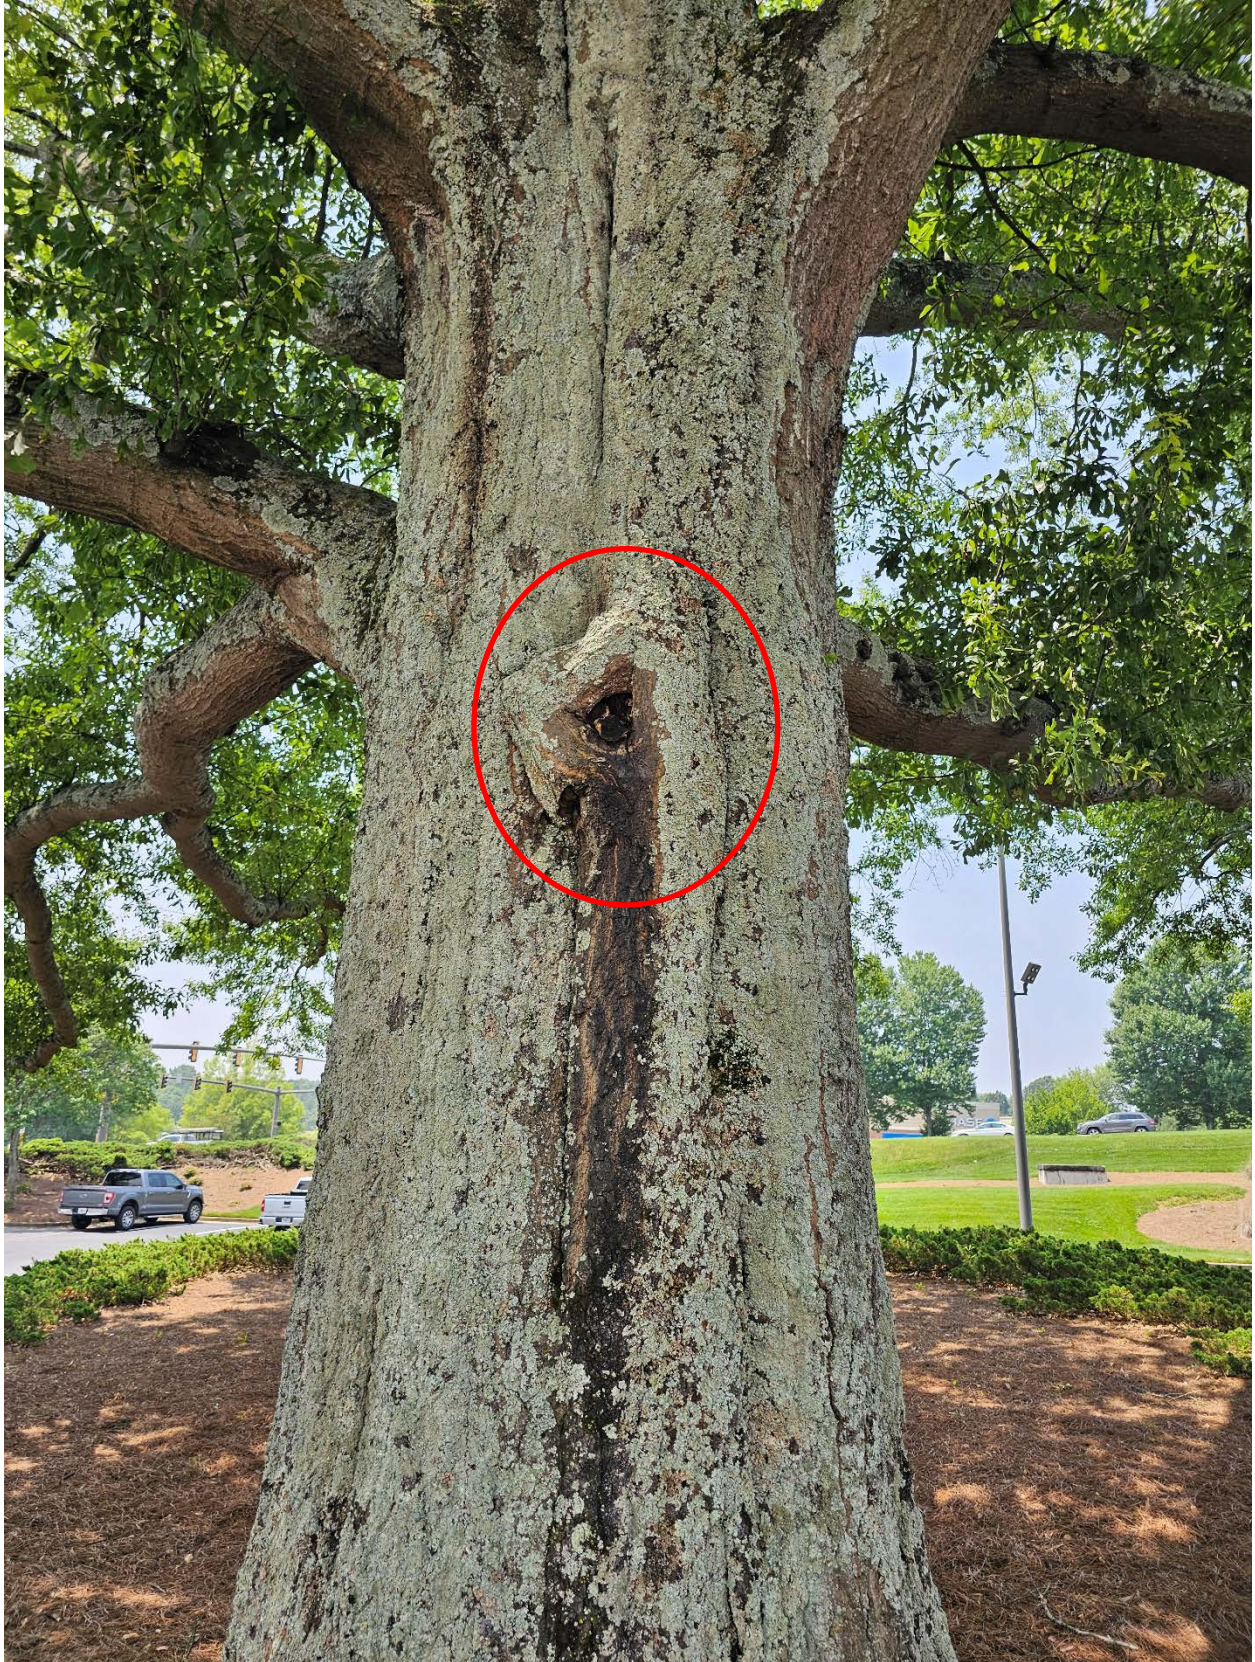
Figure 4. Decay in tree trunk

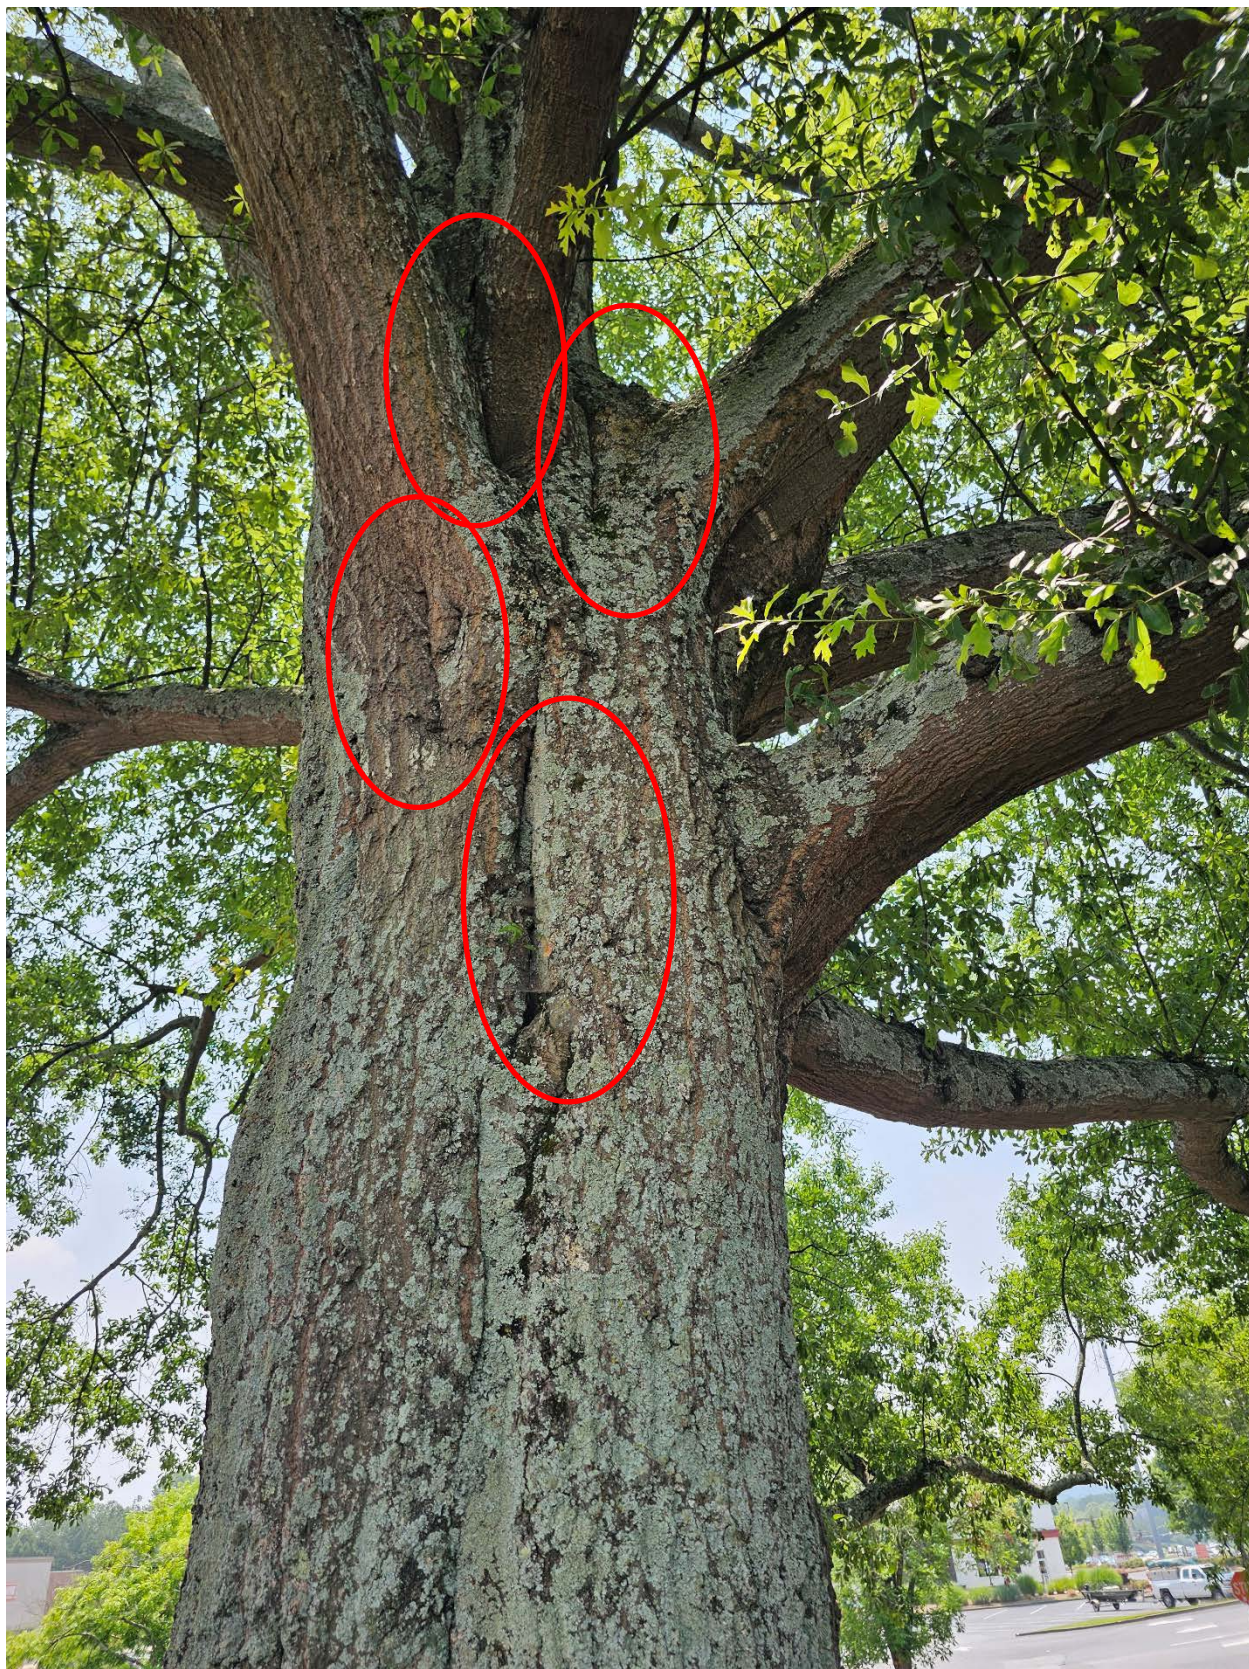
Figure 5. Multiple areas of bark inclusion

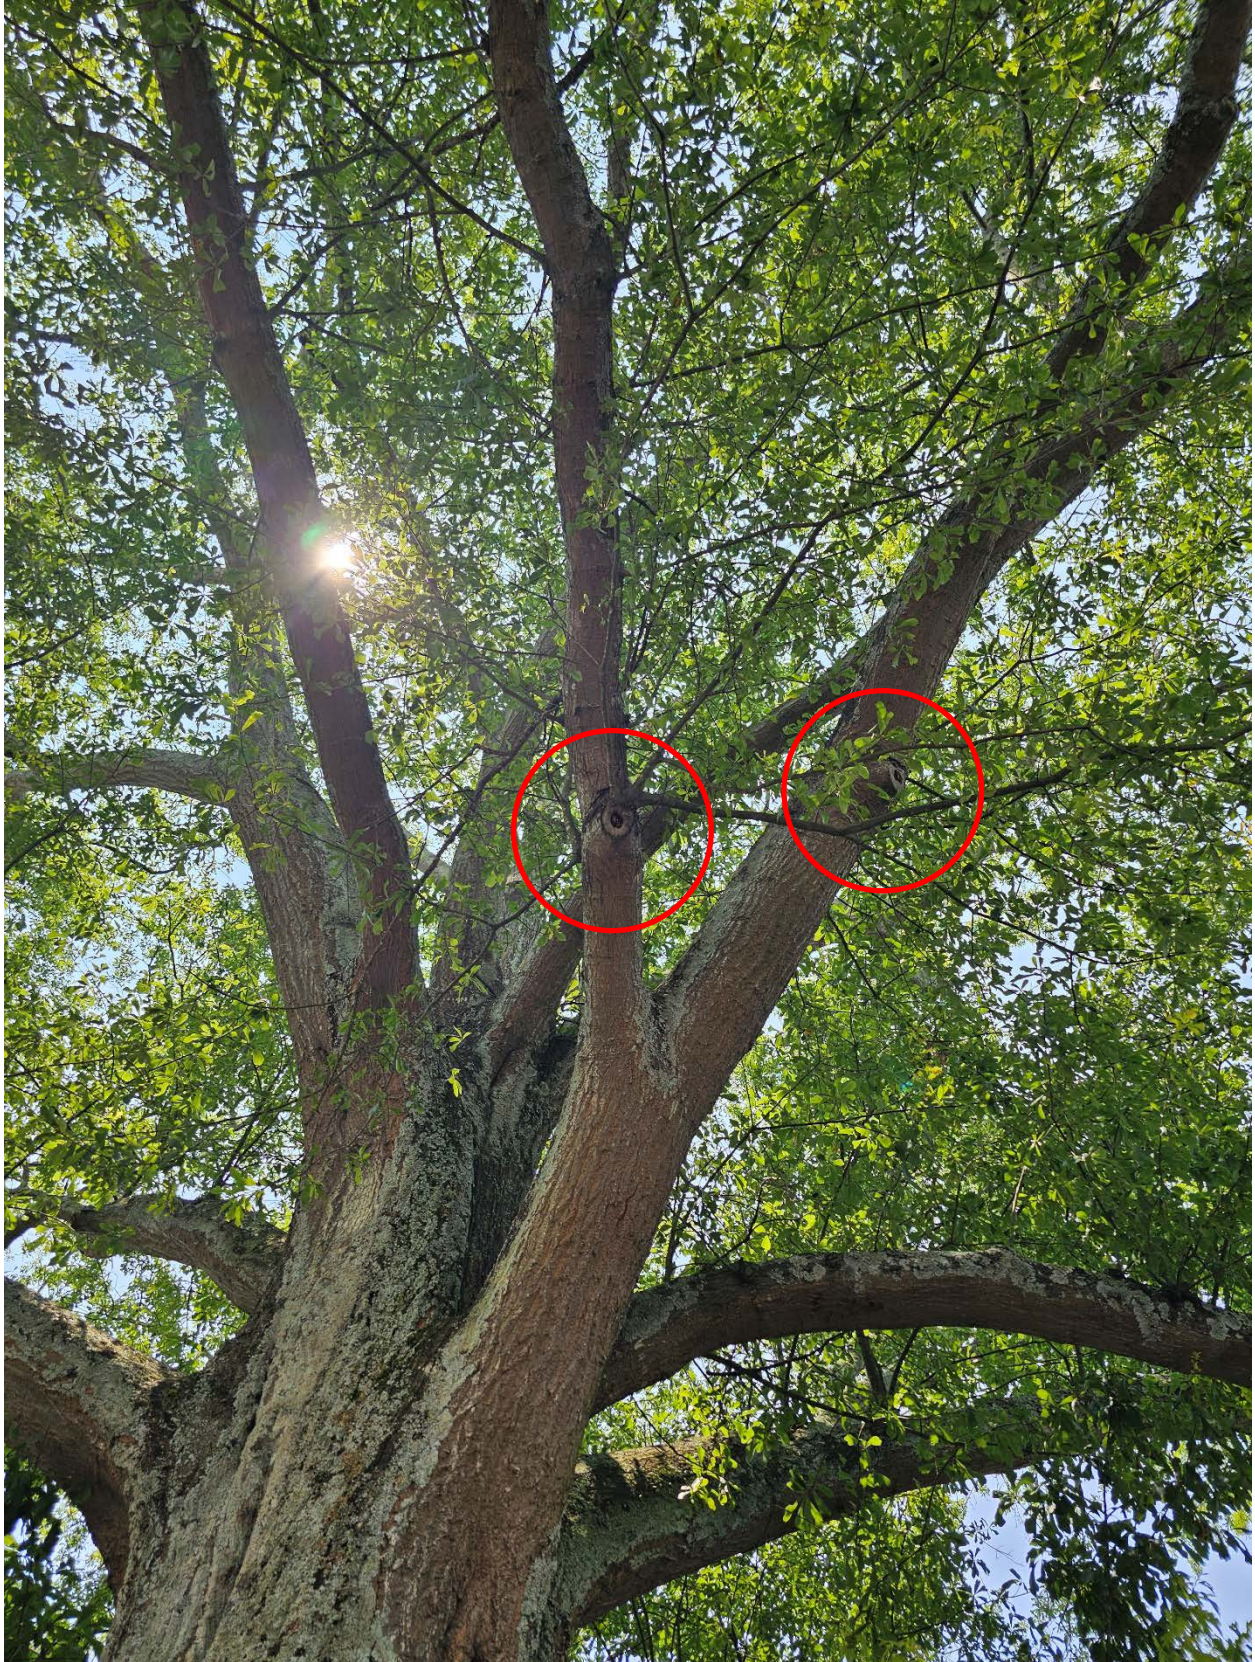
Figure 6. Decay in major limbs

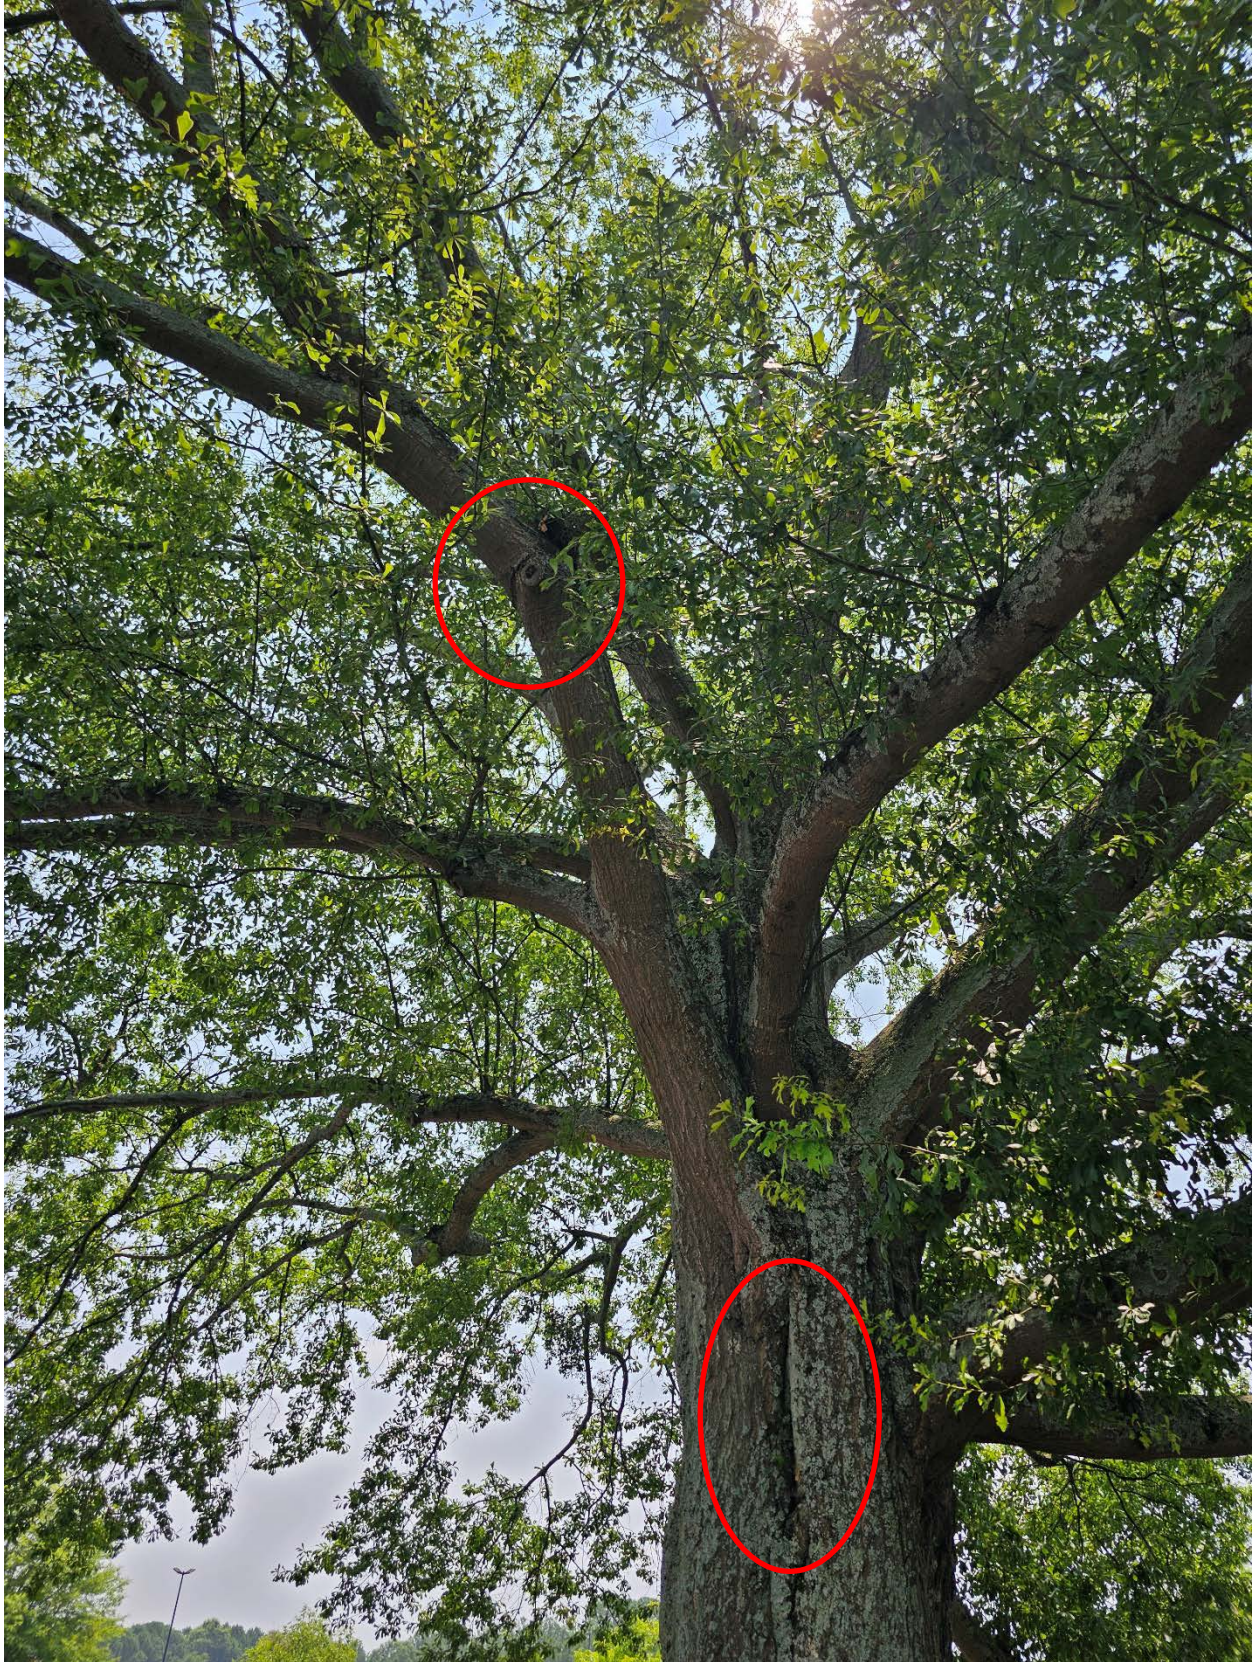
Figure 7. Decay on major limb and bark inclusion

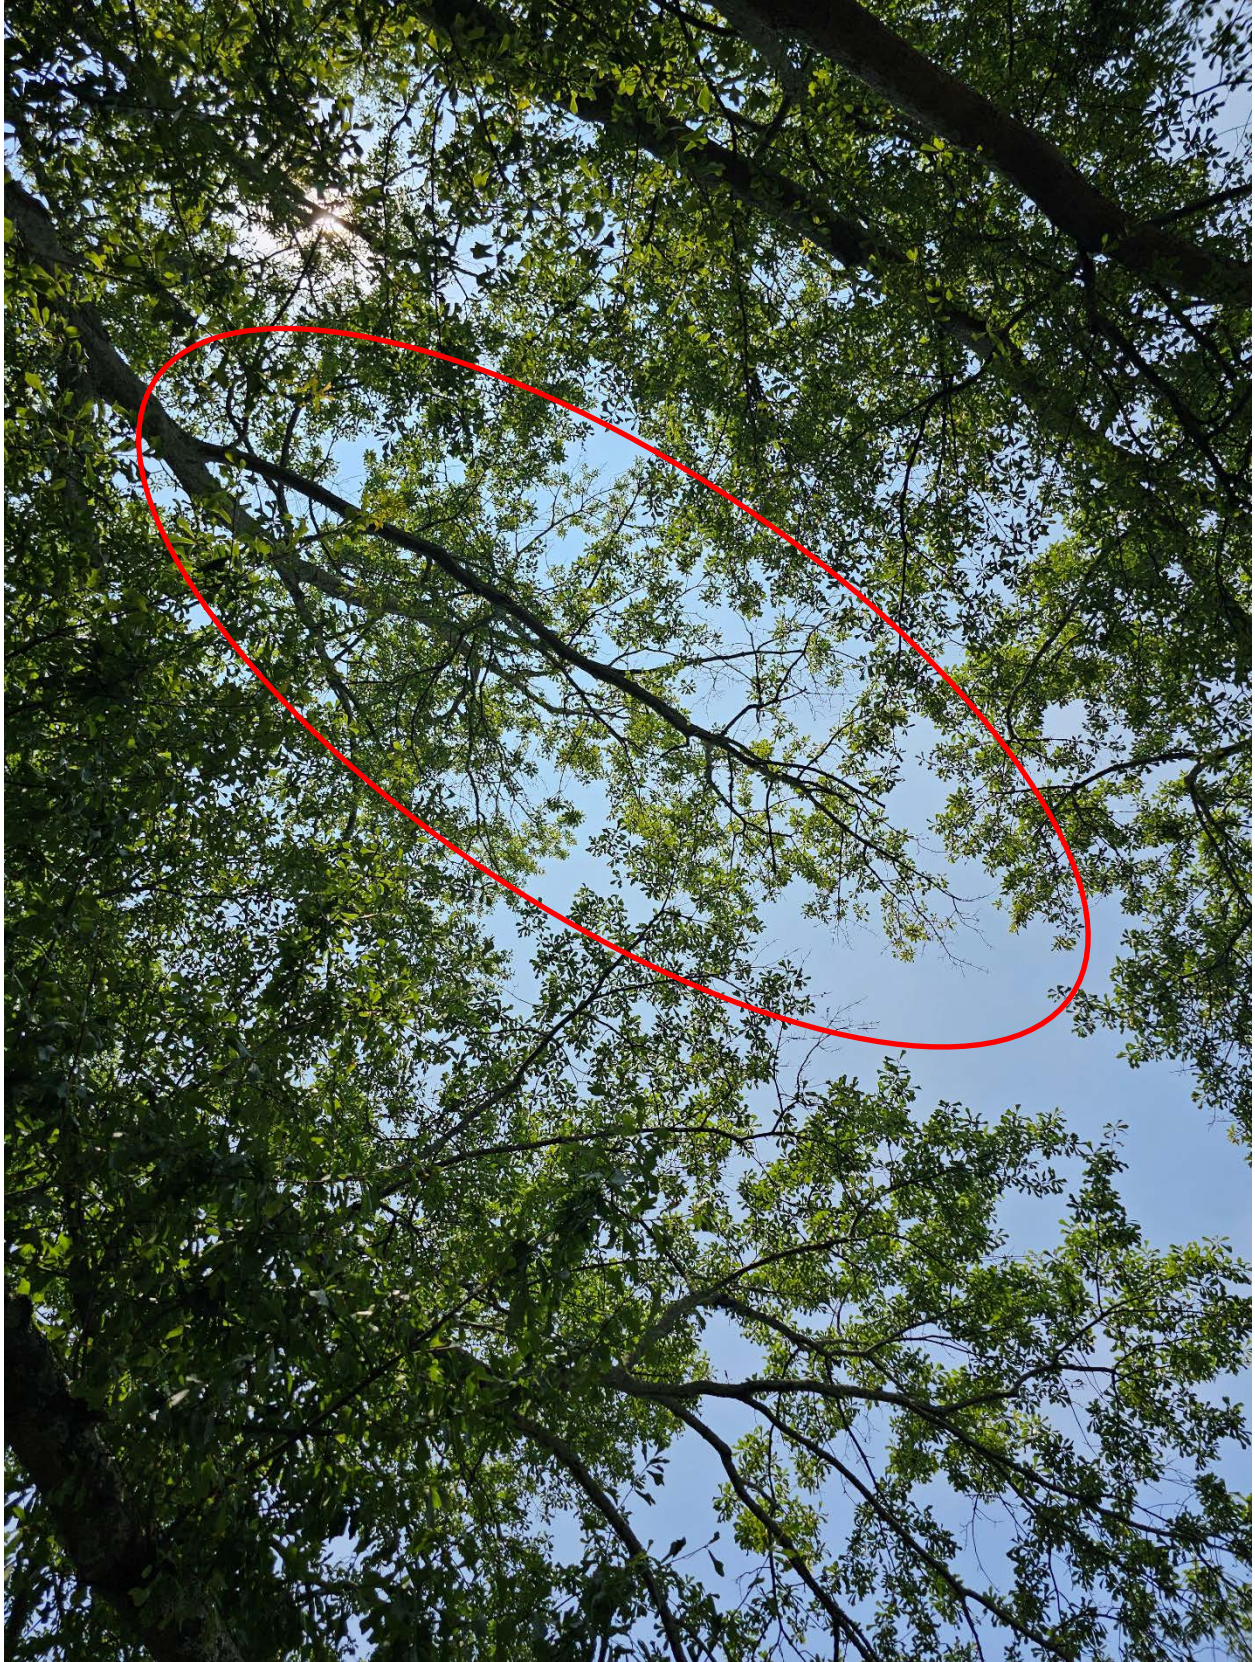
Figure 8. Major limb dieback, crown thinning, and chlorosis

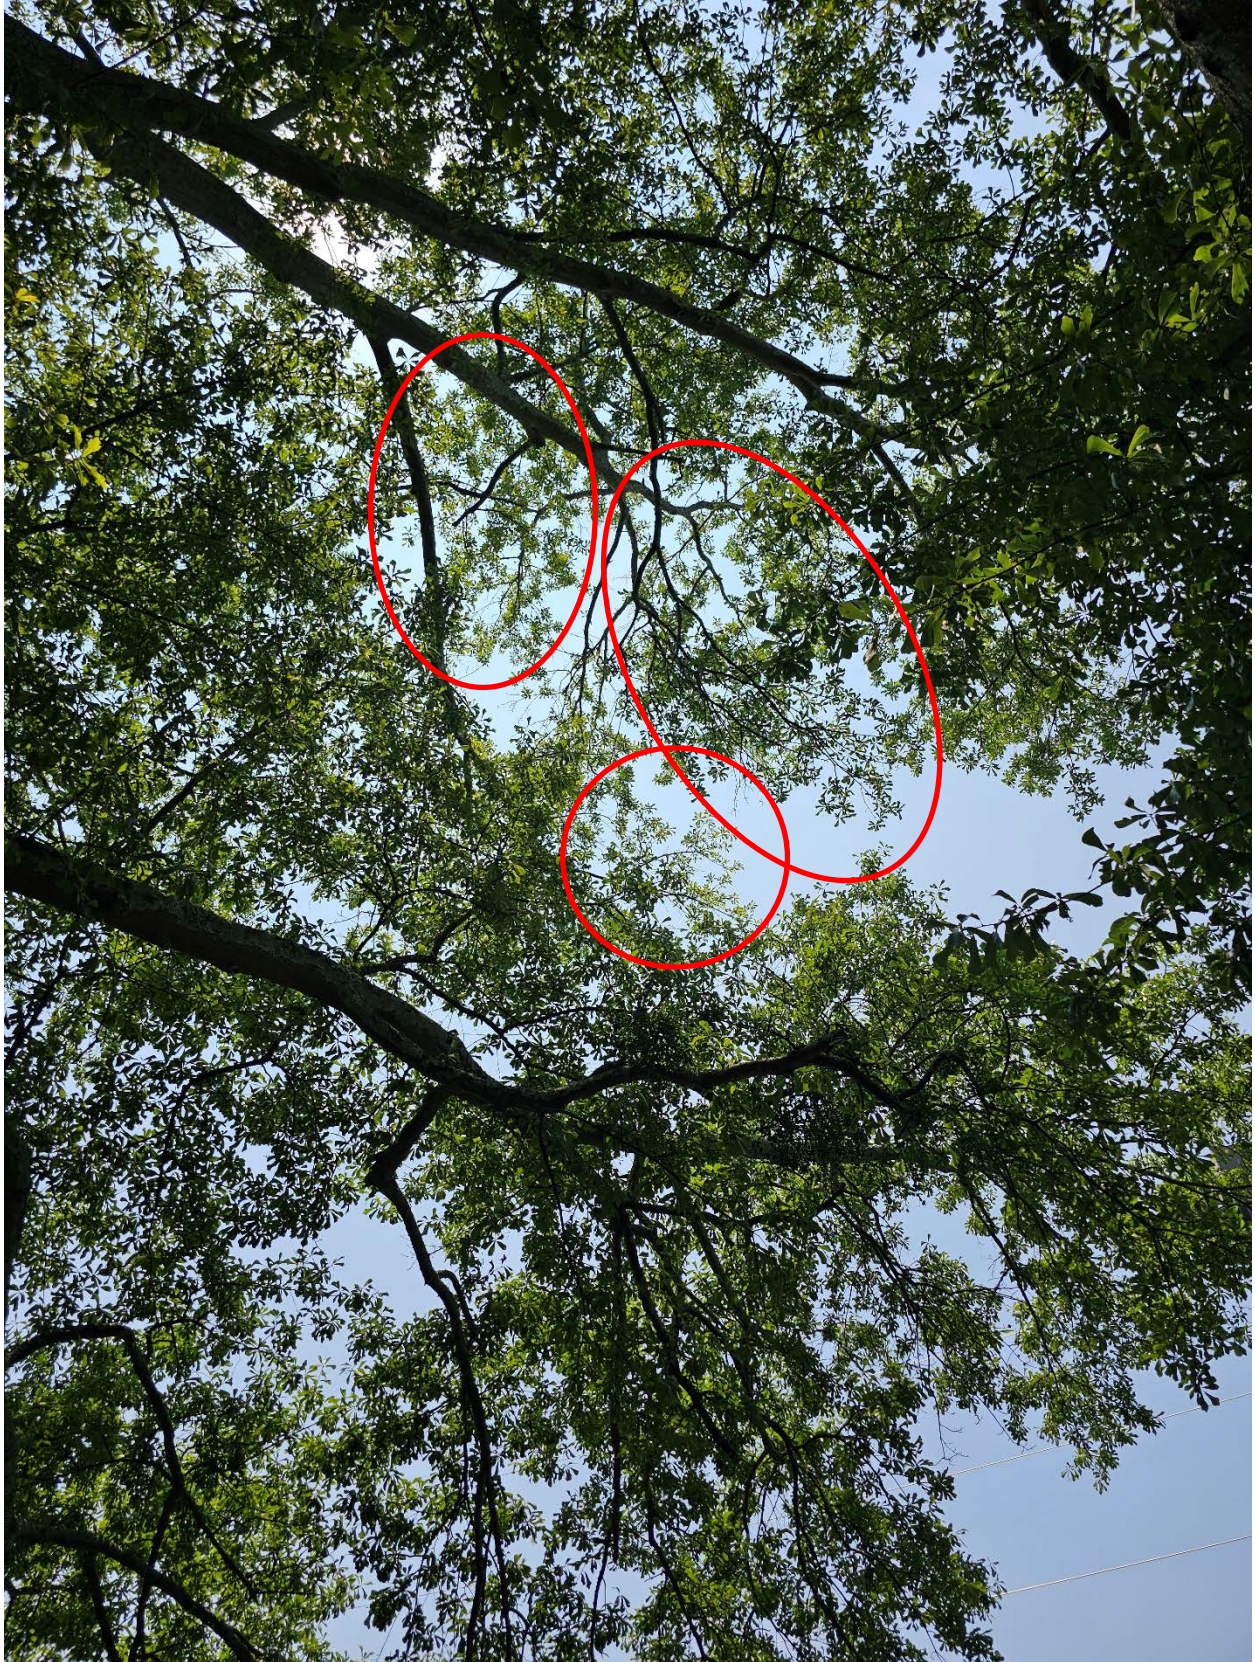
Figure 9. Major limb dieback, crown thinning, and chlorosis

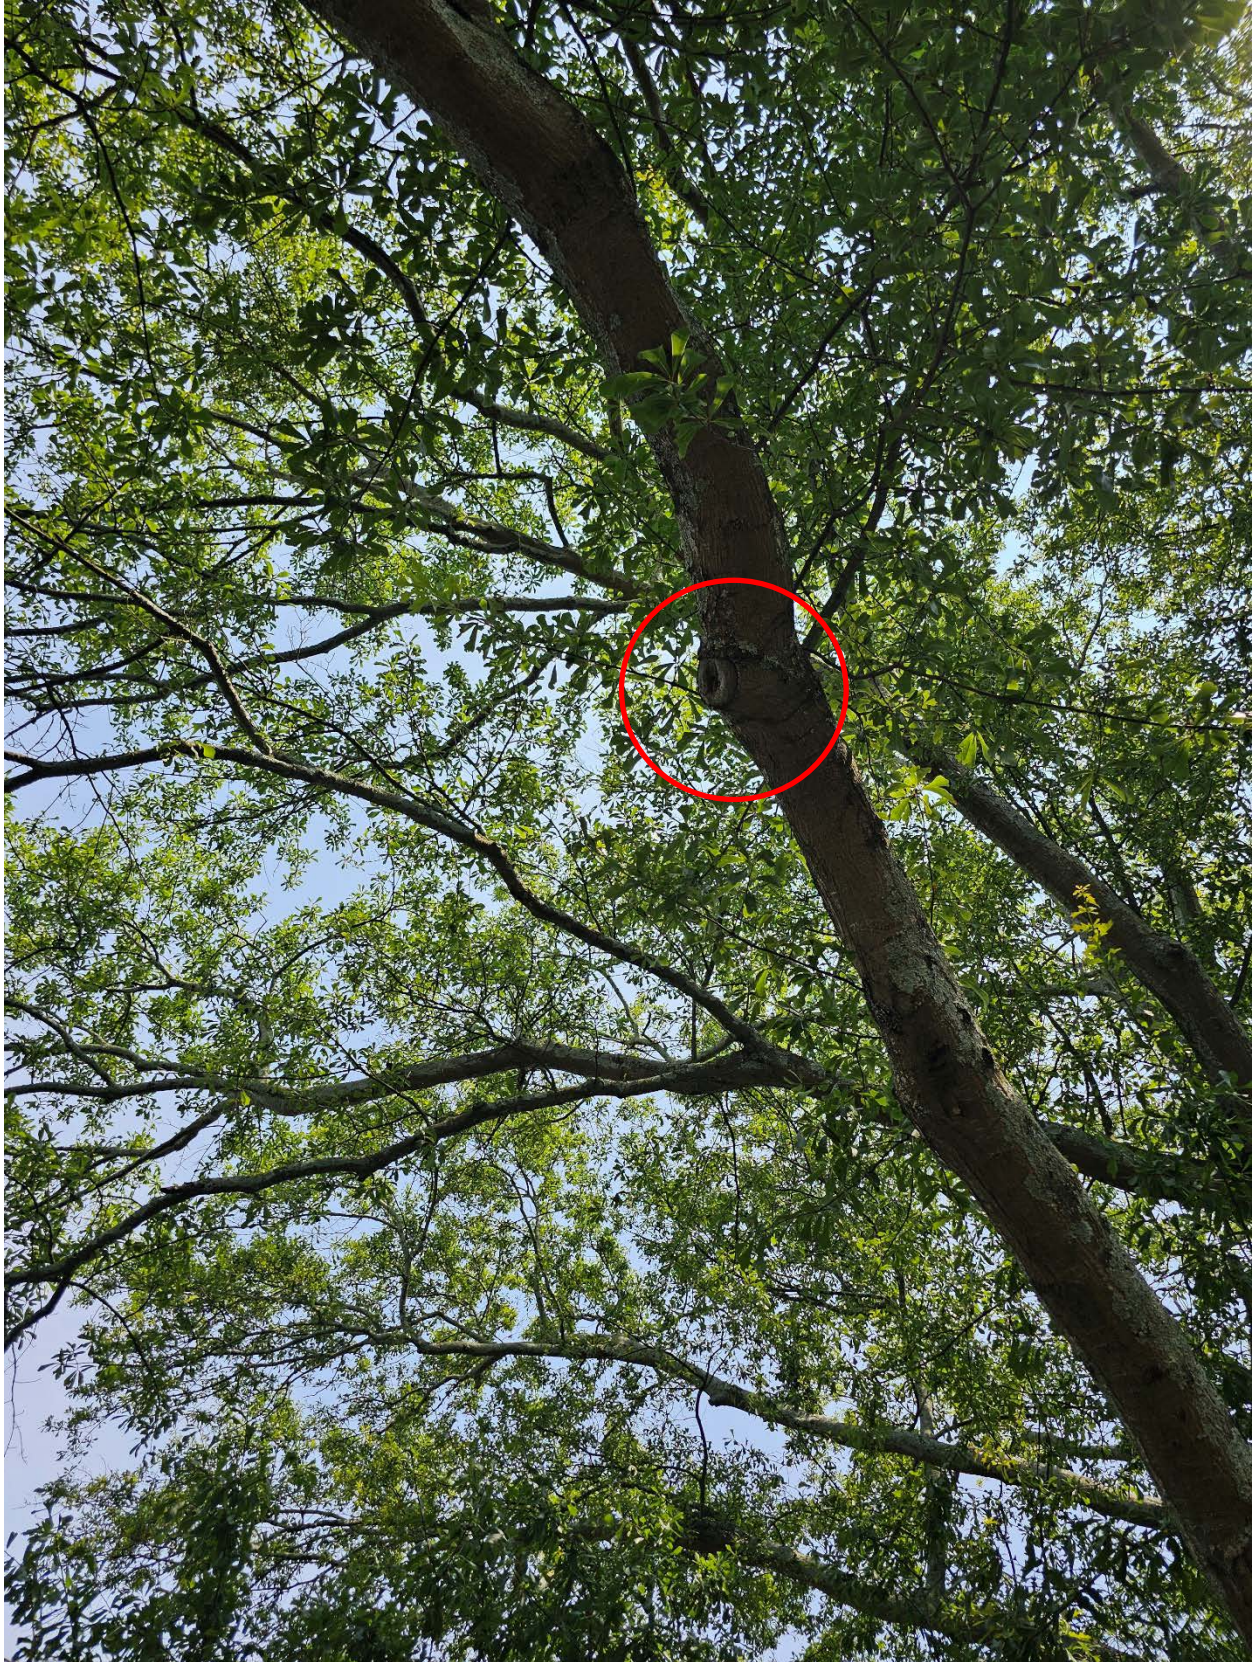
Figure 10. Decay on major limb

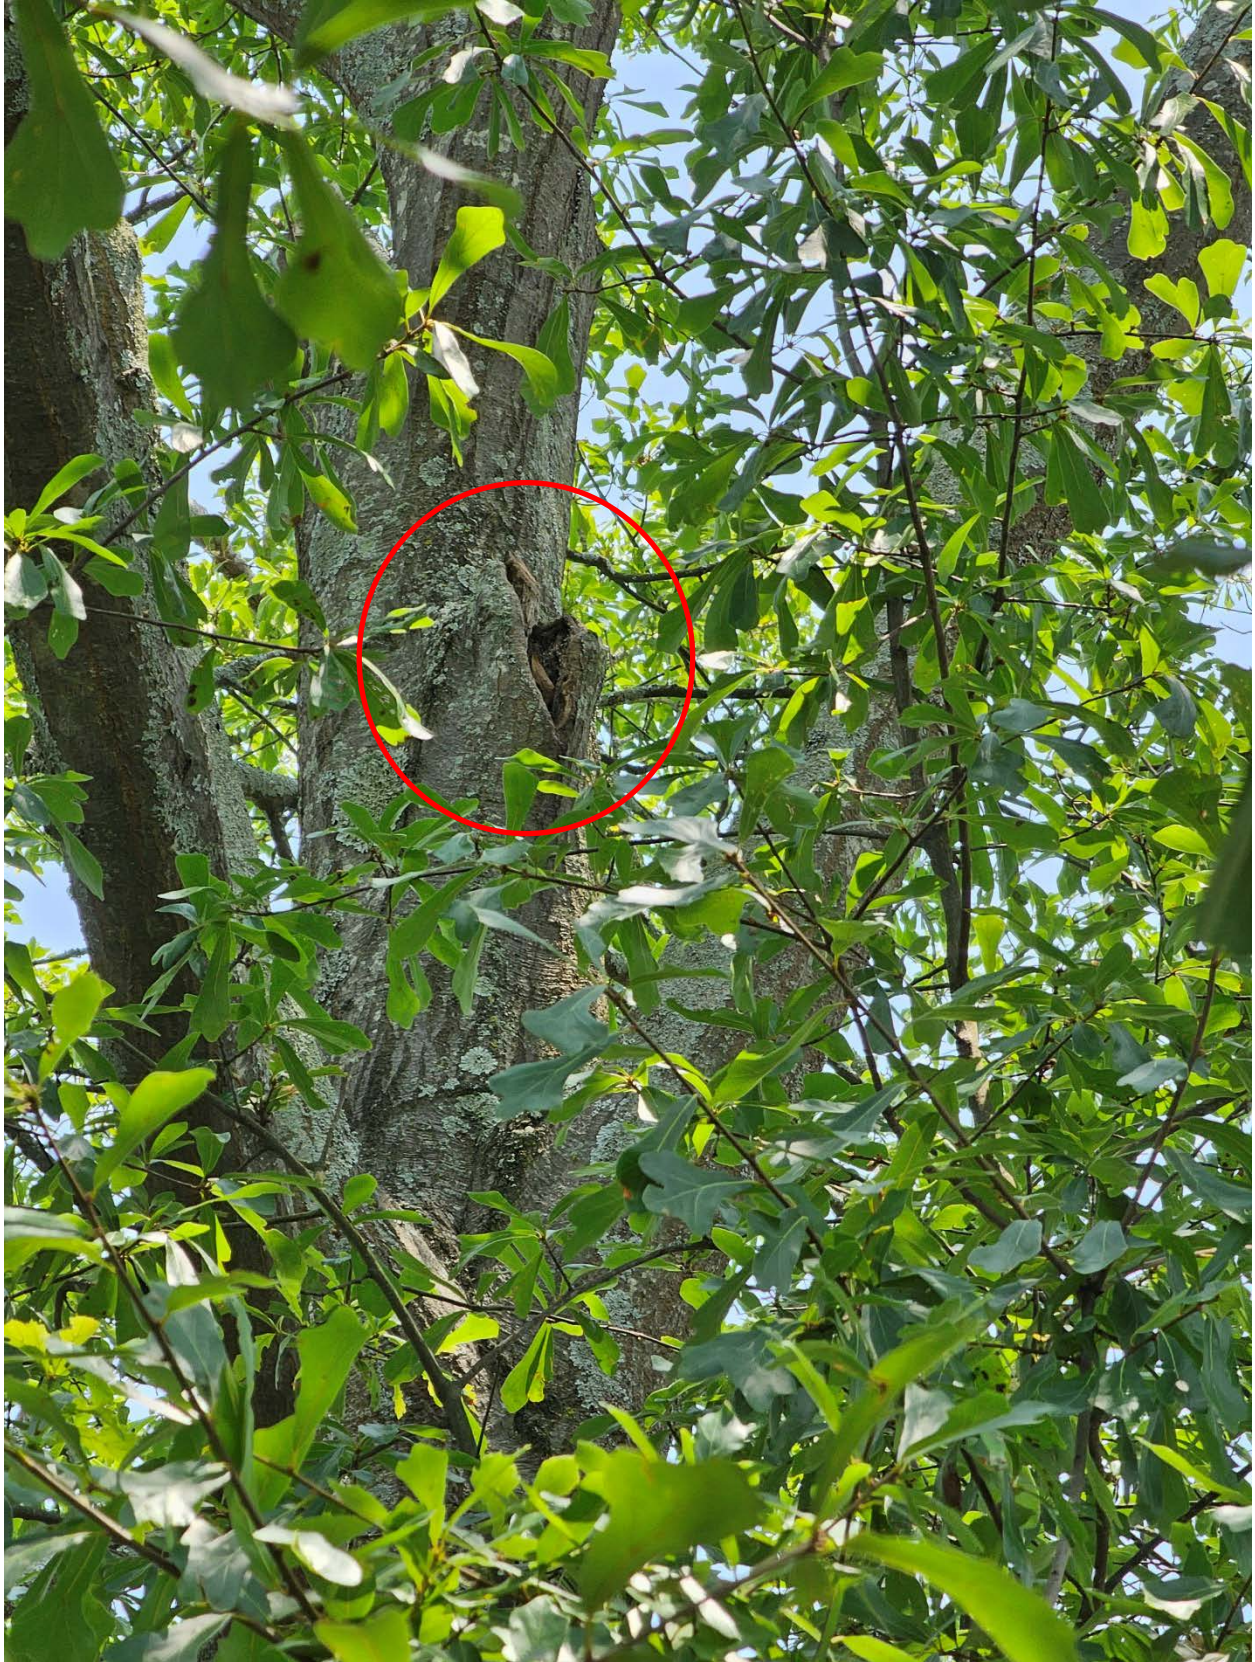
Figure 11. Decay in main stem of trunk
