ARBORIST REPORT

STATE BRIDGE RD SITE
State Bride Road
CITY OF JOHNS CREEK, GEORGIA

July 5, 2023

RE: Level 2 Arborist Inspection
State Bridge Rd – City of Johns Creek Ga Parcel: 11 094002990166

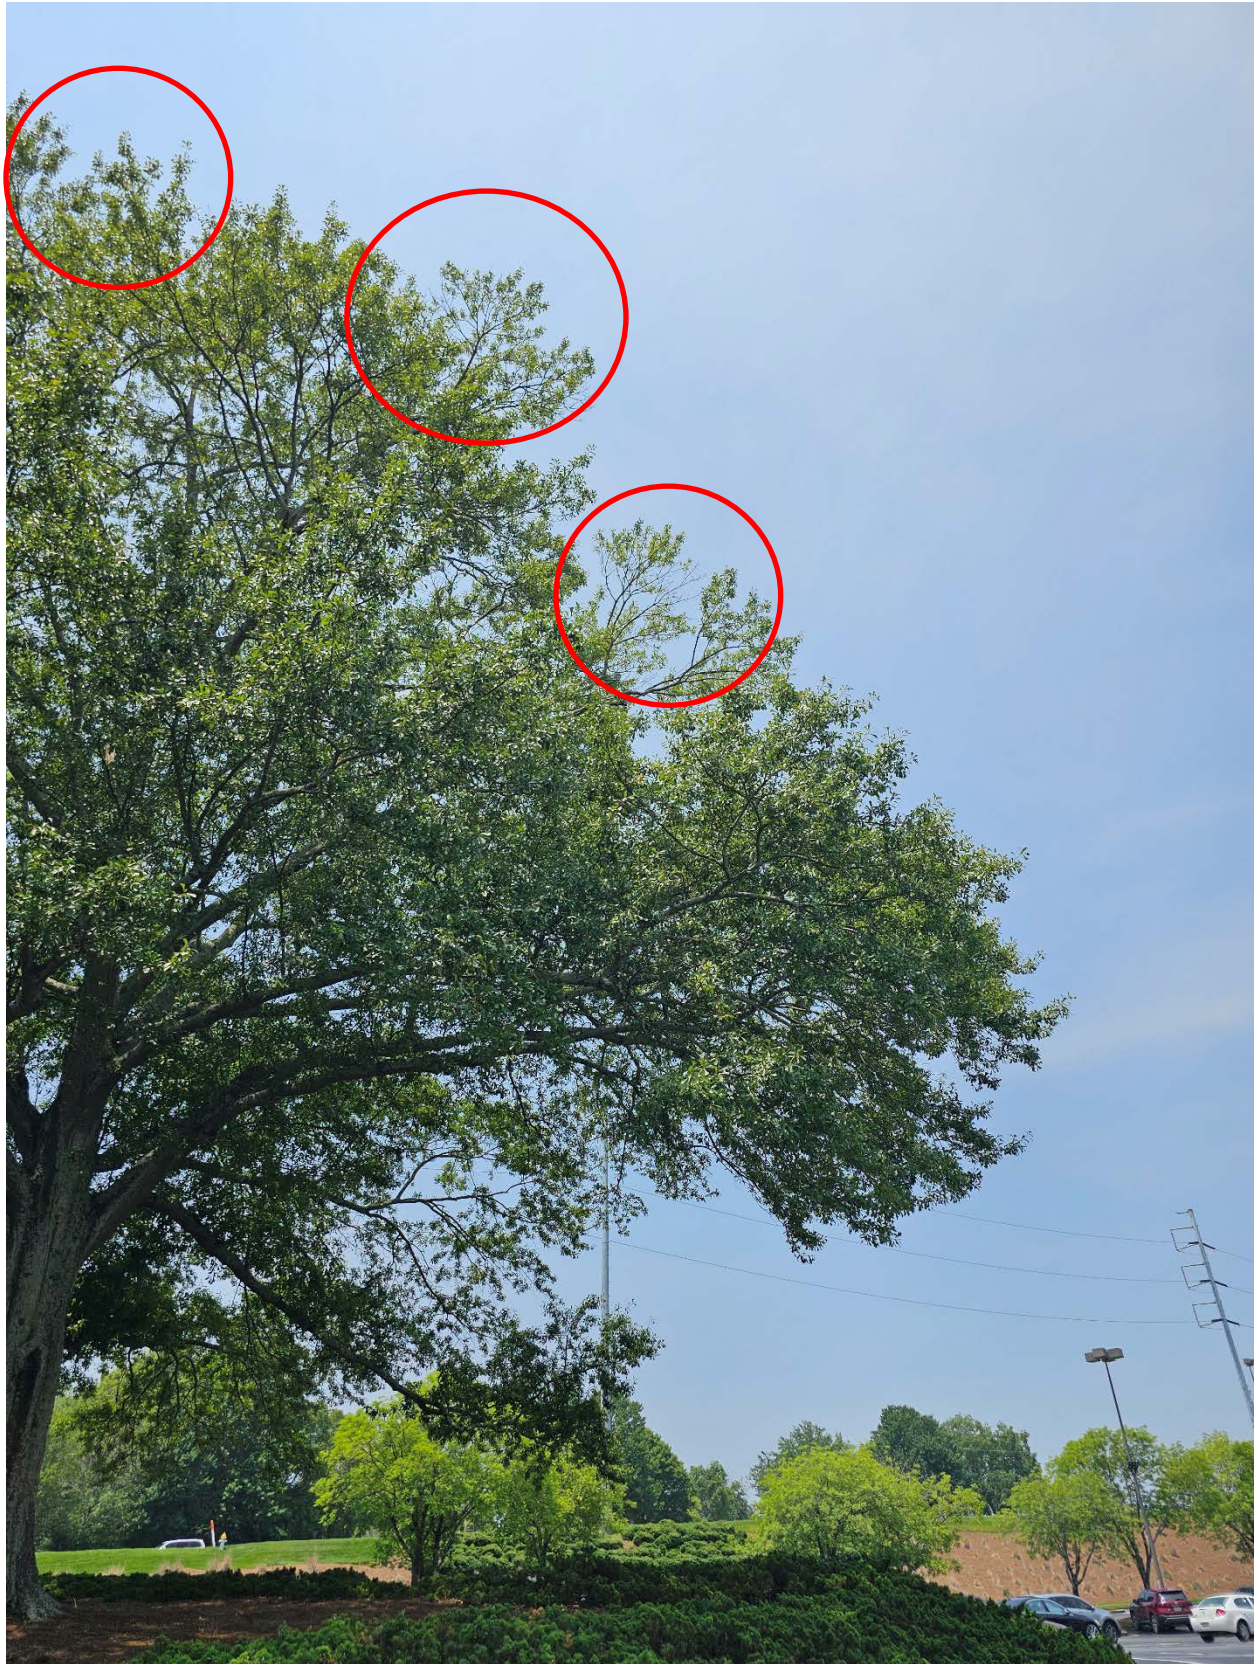
Figure 12. Thinning crown and chlorosis

Due to the severity of the structural deficiencies of these trees, there is no amount of engineering design improvements that can be made to assist in the longevity of the trees. It would be recommended to remove the tree to reduce the risk to the public and replace with a species of tree that would be more appropriate.

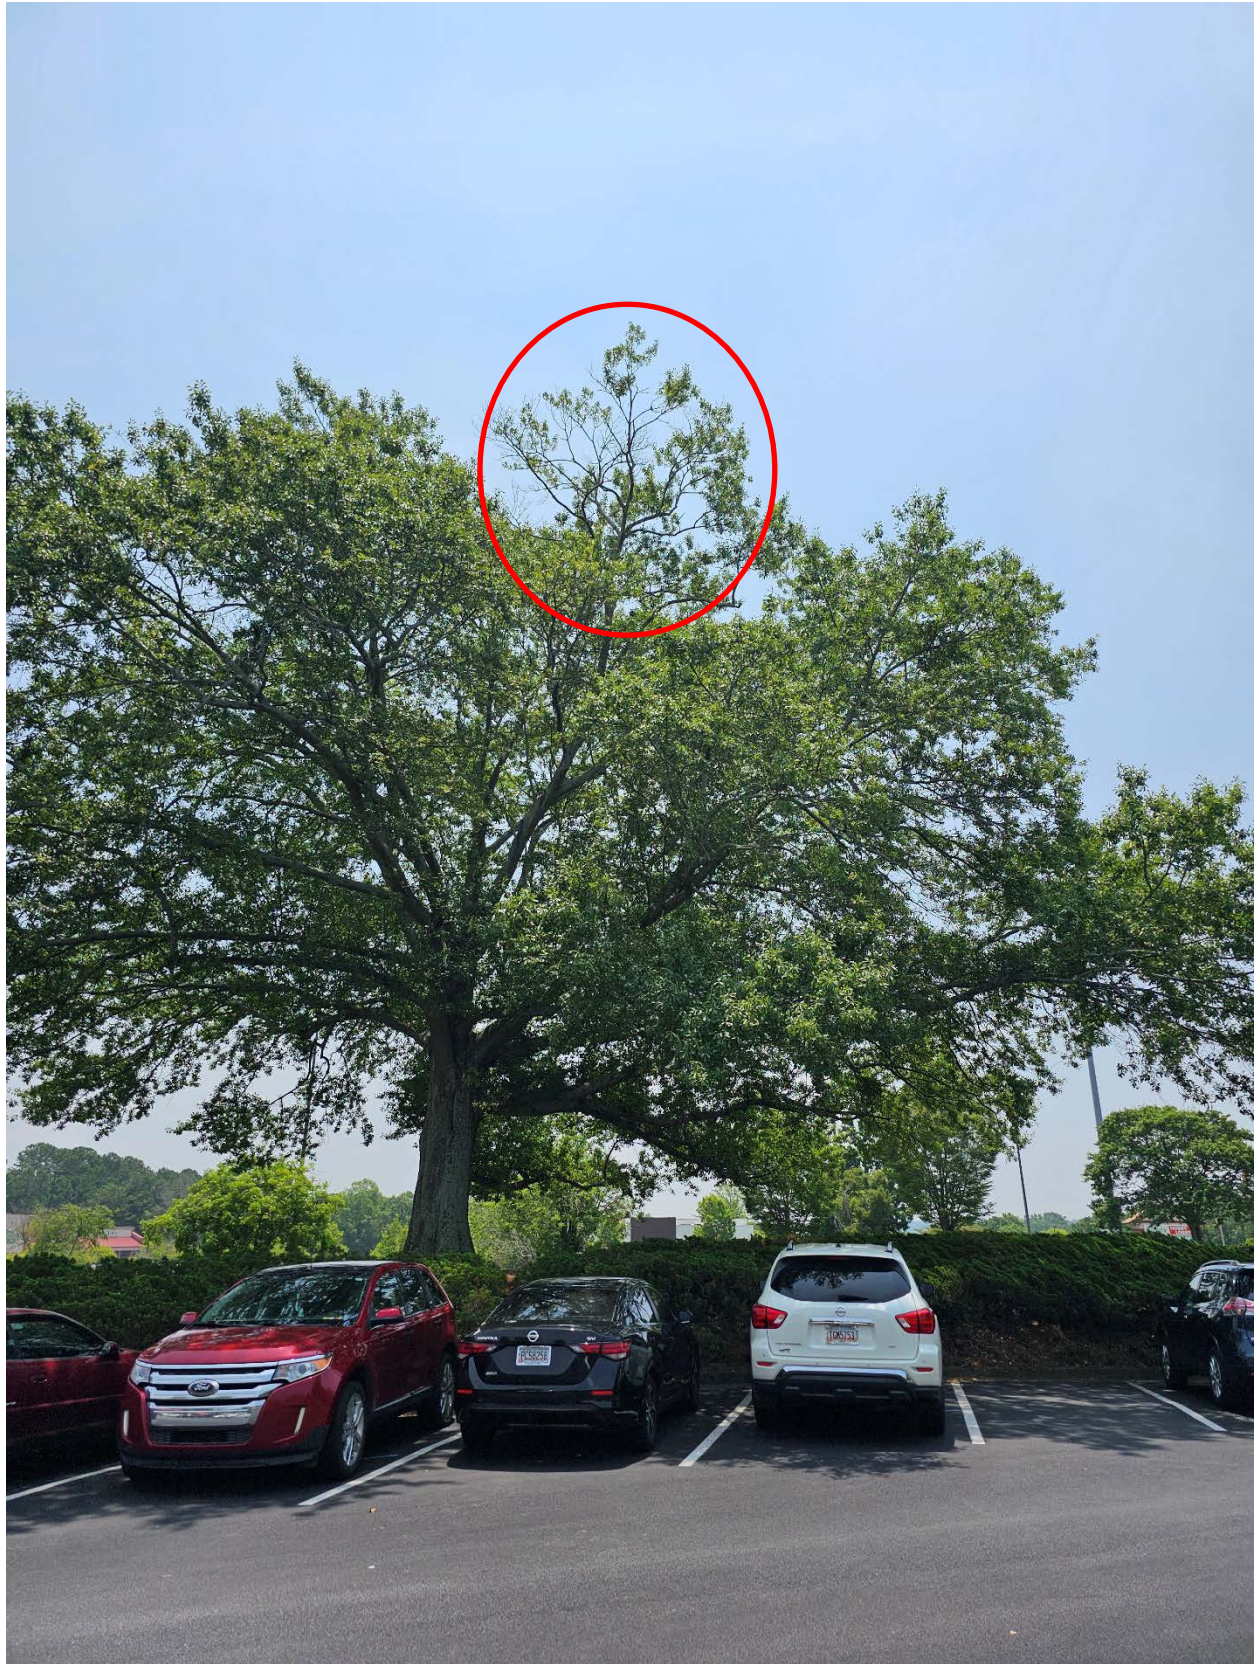
Figure 13. Thinning crown and major limb dieback
